Maintenance Rating Program

Triangle Expressway

2014 Fourth Quarter and Annual Report

NCTA Triangle Expressway Roadway and Facility Maintenance Performance Rating Program

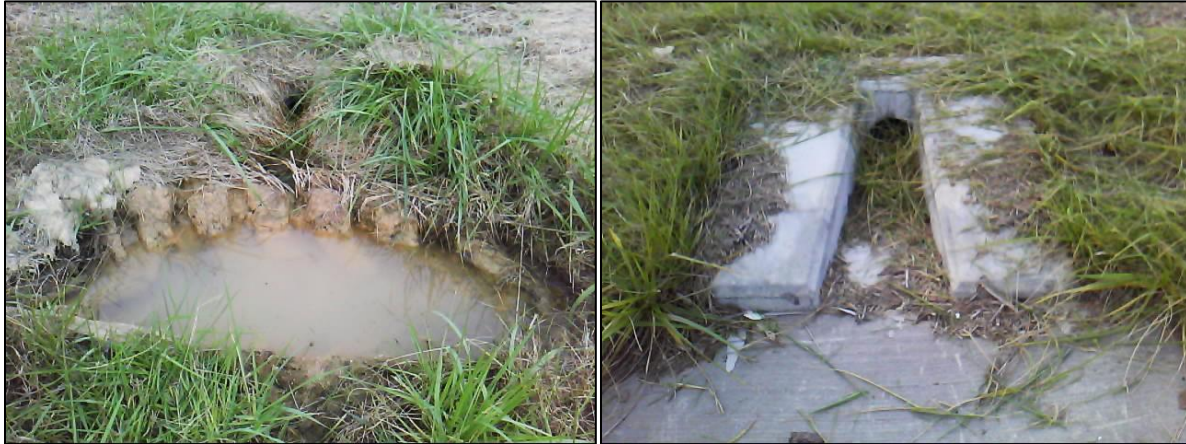
Figure 3: Miscellaneous Drainage Failures

Miscellaneous Drainage (32 rating – 17 of the 25 assets failed). Out of the 17 miscellaneous drainages that failed, 12 failed because of obstruction and 5 failed because of erosion. In order to avoid affecting the natural flow of water near the drainage features, it is recommended for the erosion problems noted to be fixed as soon as possible. It is also recommended that the maintenance provider plan to routinely clean these drainage features to remove any debris that may have been washed into the structure or grown up around it.

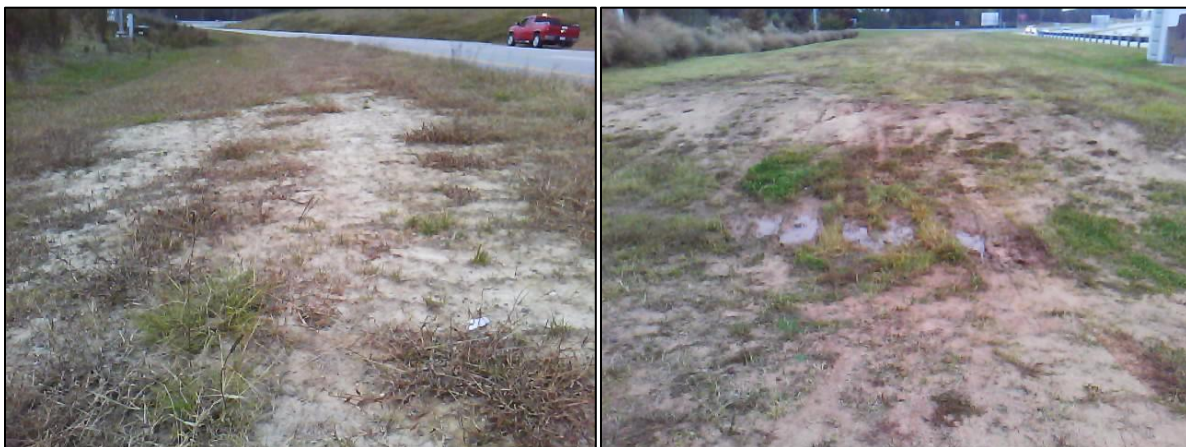
Figure 4: Turf Failures

Turf Condition (46 rating – 33 of the 61 assets failed). All 33 turf areas failed because of bare ground. Two (2) of the failing turf area can be seen in the figure below. Many of the bare ground areas previously had active Bermuda and Centipede runners growing that are now dead. It is suspected this was caused by low cutting heights during extreme heat months. With such a noticeable drop over the last few assessments in the turf condition it is recommended that the maintenance provider schedule overseeding of these areas with warm season grasses and possibly add soil enrichment to increase the chances of survival. It is further suggested that mowing heights continue to be closely monitored especially during the months of extreme heat conditions.

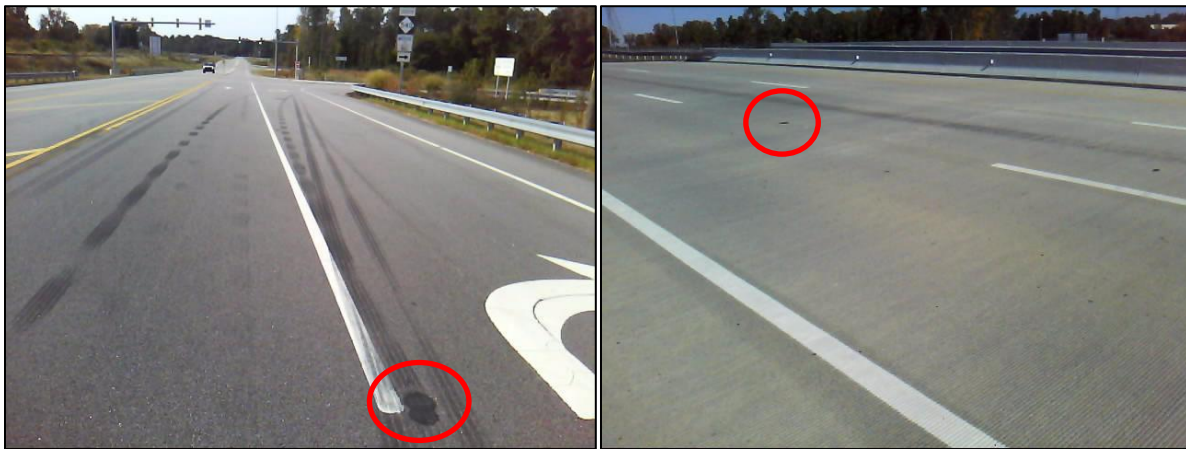
Figure 5: Pavement Markers Failures

Pavement Markers (55 rating – 14 of the 31 assets failed). Out of the 14 linear segments that failed due to pavement markers, 8 did not pass the night time inspection due to lack of markers' reflectivity and 7 of the 14 failed because of missing markers. **Figure 5** shows two examples of the missing markers failures found along the facility.

The Triangle Expressway saw several rounds of frozen precipitation this past winter where plows removed the non-snowplowable markers from bridge decks. It is recommended for the maintenance provider to consider replacing bridge deck markers as soon as practical at the end of each winter season. With attentive effort towards specific minor deficiencies the overall MRP score can be maintained cost effectively above the 90 percentile threshold.

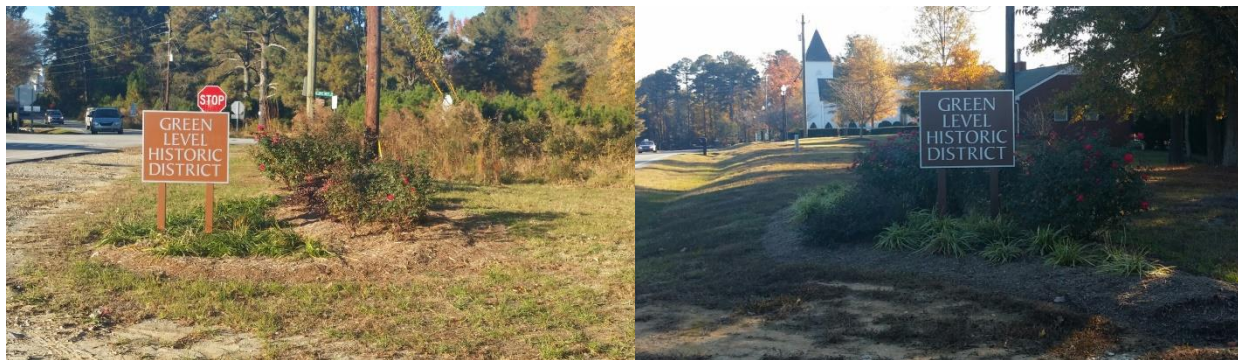
Figure 6: Green Level West Historic District Signs

In addition, the report provides findings of the Green Level Historic District signs inspections. This quarter, all Green Level Historic District signs were found to be in good physical condition, and the landscaped areas around the signs were well maintained.

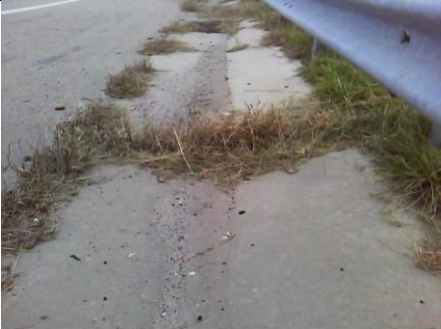
#	Material Type	Object ID	Failure Type	Photo	GIS Reference Page
1	Valley	CG_80	Material Accumulation

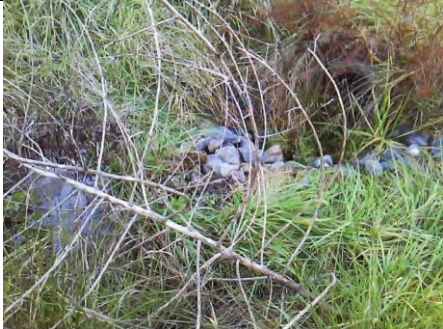
#	Material Type	Object ID	Failure Type	Photo	GIS Reference Page
1	Cross Pipe	DP_709	Erosion

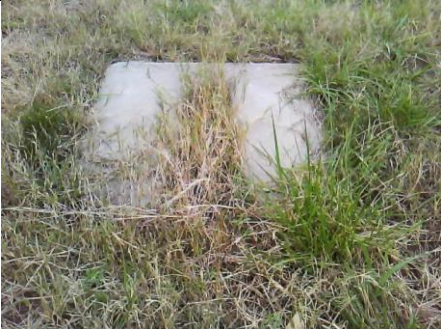
#	Material Type	Object ID	Failure Type	Photo	GIS Reference Page
1	Shoulder Drain	MDP_2	Obstruction

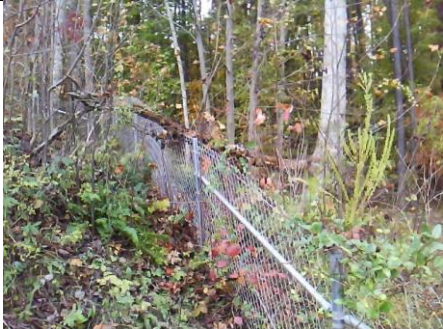
#	Material Type	Object ID	Failure Type	Photo	GIS Reference Page
1	Chain Link	FN_236	Vegetation Compressing Fence

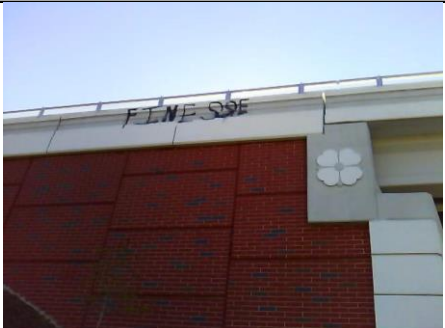
#	Material Type	Object ID	Failure Type	Photo	GIS Reference Page
1	N/A	GR_1	Graffiti on Bridge Railing

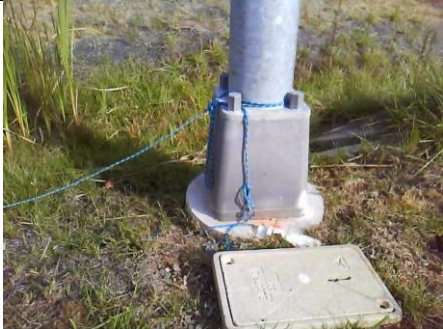
#	Material Type	Object ID	Failure Type	Photo	GIS Reference Page
1	Single Roadway	HL_229	Functional Damage

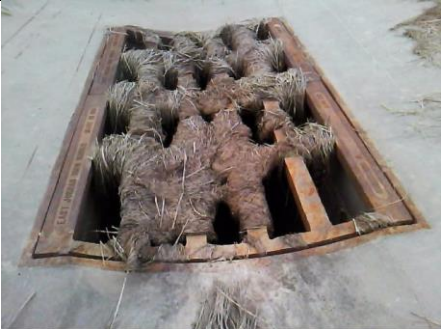
#	Material Type	Object ID	Failure Type	Photo	GIS Reference Page
1	Inlet	IN_238	Obstruction

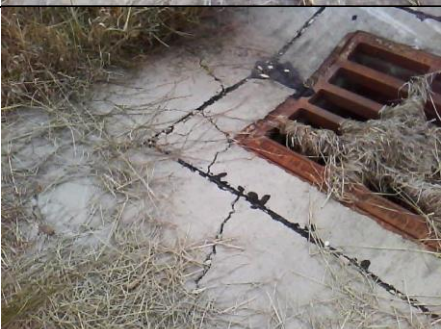
A7
3	Inlet	IN_295	Surface Damage

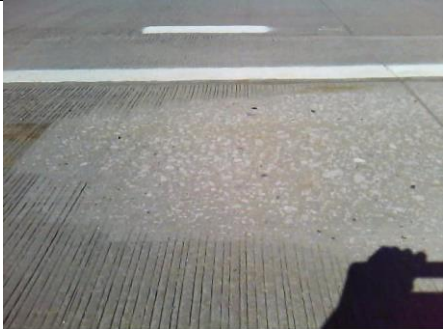
#	Material Type	Object ID	Failure Type	Photo	GIS Reference Page
1	Concrete	LS_308	Spalling

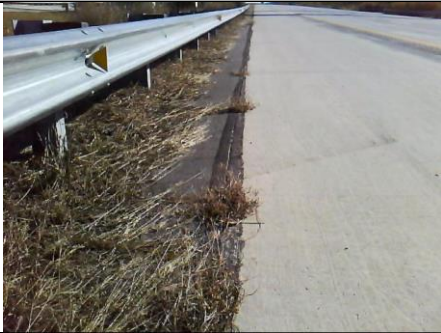
#	Material Type	Object ID	Failure Type	Photo	GIS Reference Page
1	Concrete	LS_129	Paved Shoulder Joint

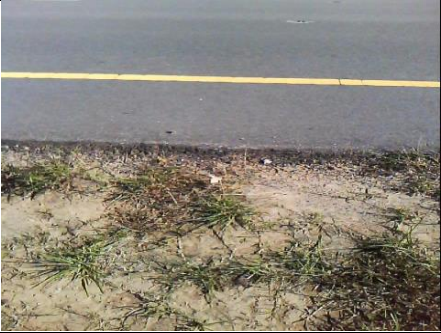
#	Material Type	Object ID	Failure Type	Photo	GIS Reference Page
1	Unpaved Shoulder	LS_209	Shoulder Dropoff

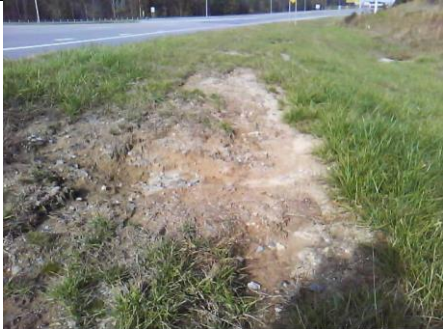
#	Material Type	Object ID	Failure Type	Photo	GIS Reference Page
1	Slope	LS_364	Slope Failure

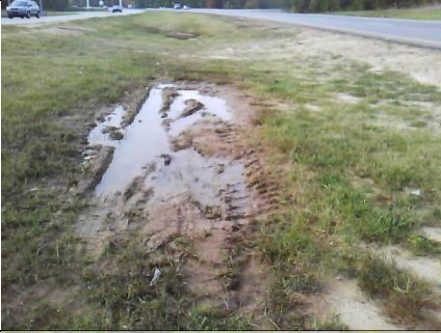
#	Material Type	Object ID	Failure Type	Photo	GIS Reference Page
1	Unpaved Lateral Ditch	LS_542	Erosion

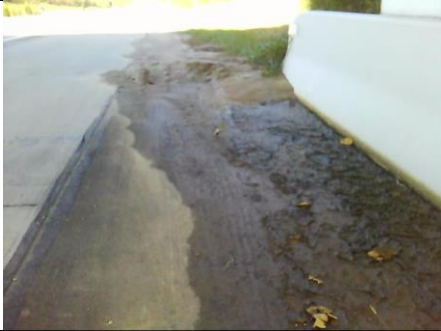
#	Material Type	Object ID	Failure Type	Photo	GIS Reference Page
1	Concrete	LS_53	Travelway Sweeping

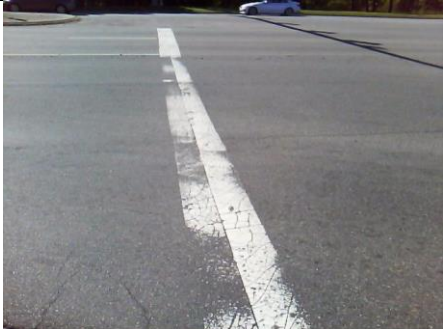
#	Material Type	Object ID	Failure Type	Photo	GIS Reference Page
1	Stop Bar	PS_626	Daytime Symbol Visibility

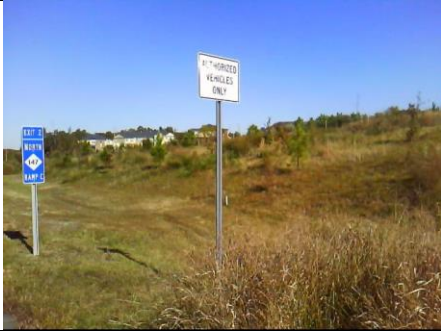
#	Material Type	Object ID	Failure Type	Photo	GIS Reference Page
1	Authorized Vehicles	SN_326	Height Requirement

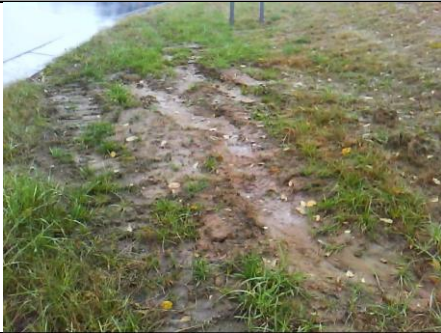
#	Material Type	Object ID	Failure Type	Photo	GIS Reference Page
1	Turf	TF_28	Bareground

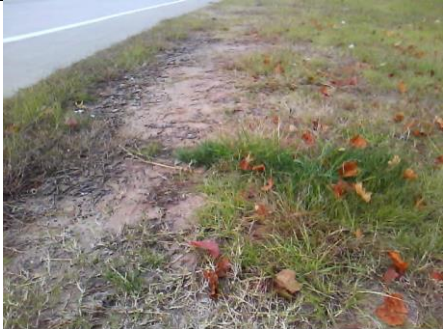
#	Material Type	Object ID	Failure Type	Photo	GIS Reference Page
33	Turf	TF_1009	Bareground

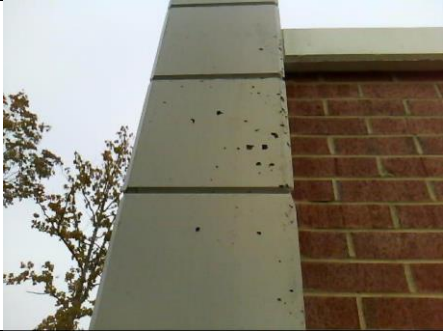
#	Material Type	Object ID	Failure Type	Photo	GIS Reference Page
1	Screen Wall	WL_31	Spalling

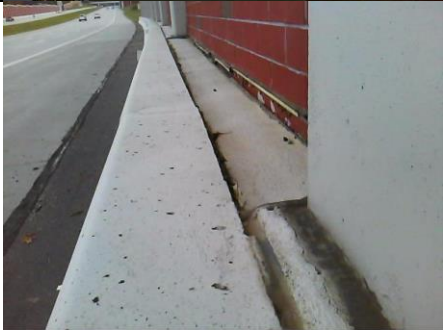
A52
2	Sound Wall	WL_95	Cracked Joint
